Heron Creek Community Association

PAVEMENT ASSESSMENT REPORT

DMK Associates, Inc.

Revised November 2024

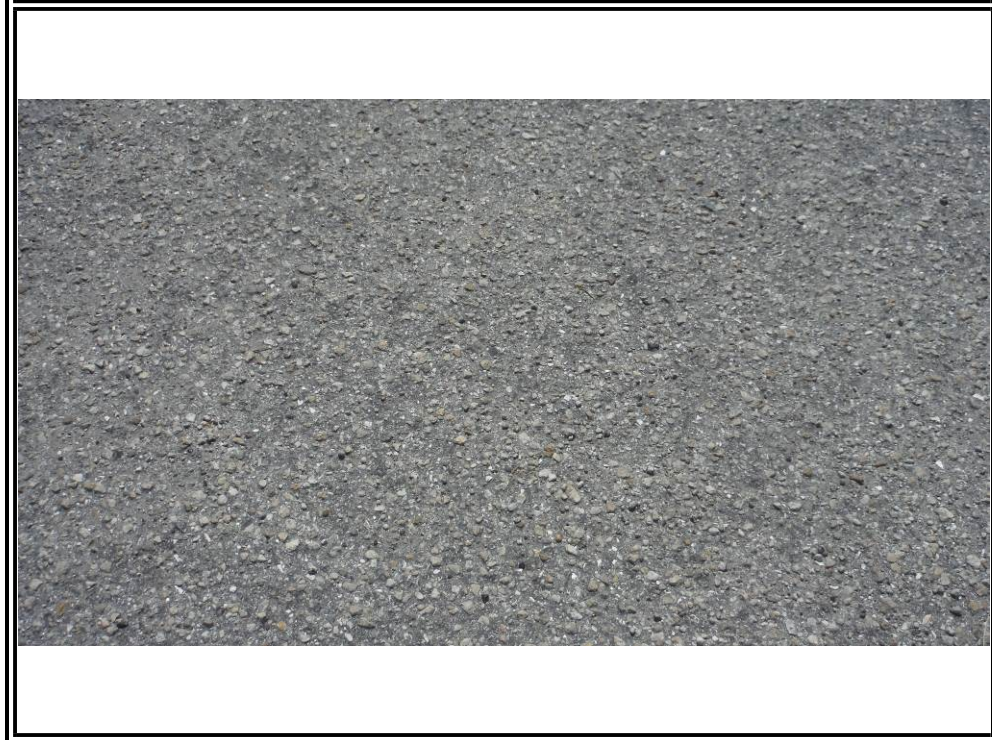
DMK did a cursory review of a majority of the roadways within HCCA. It was noted that most of the roadways have exposed aggregate and longitudinal cracking at the centerline of the roadway. Some areas have small isolated potholes with additional longitudinal and transvers cracking. At one sanitary sewer manhole there are radial cracks parallel to the manhole indicating settlement issues.

Photo No. 2
**Exposed Aggregate in
Asphalt Material**

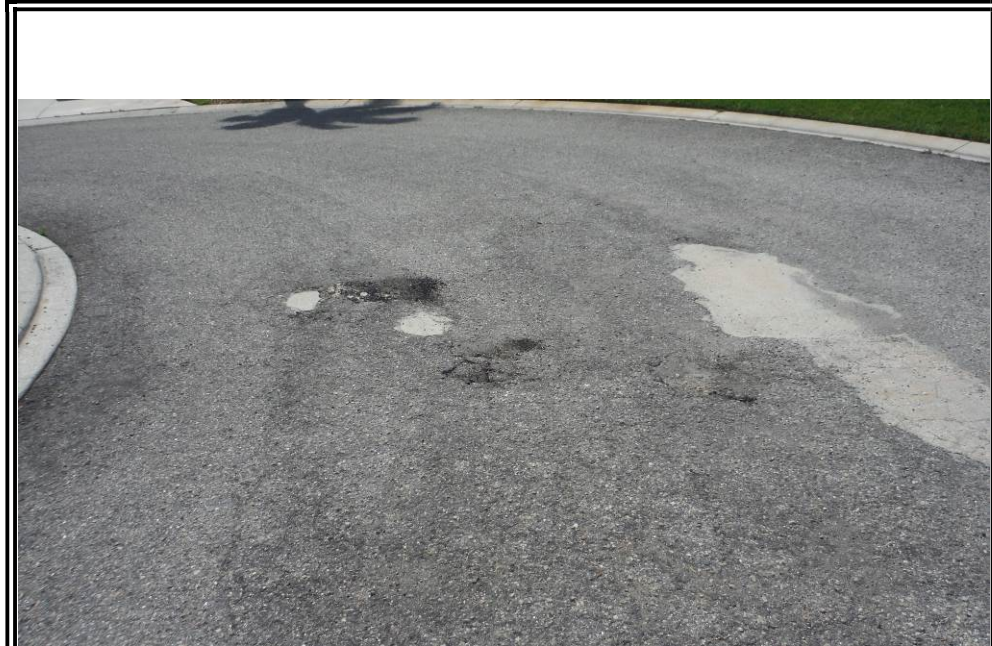
Photo No. 3

**Various Potholes in
Cul-De-Sac**

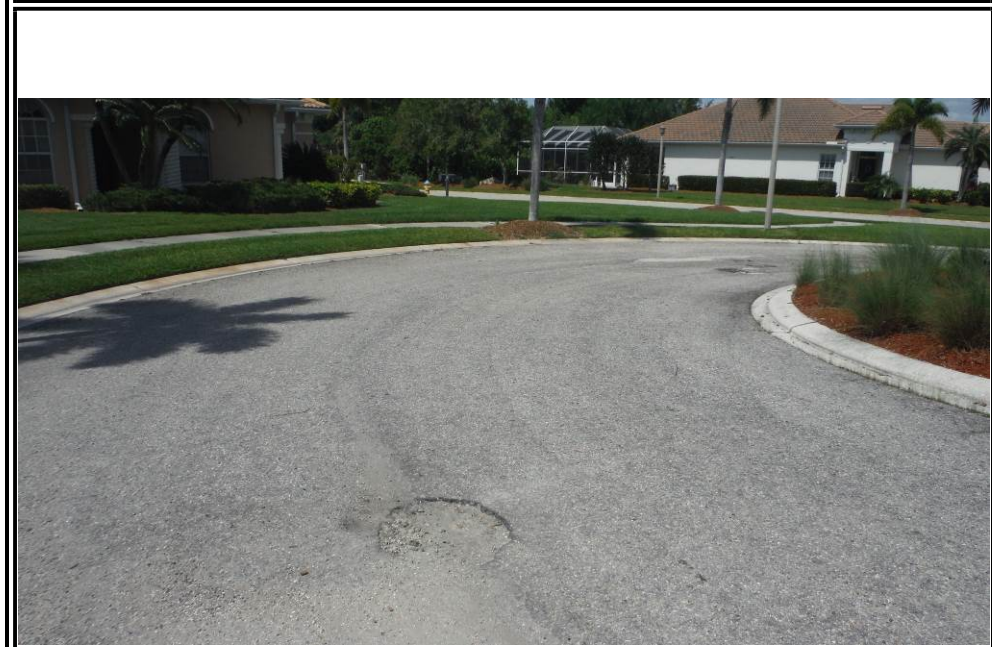
Photo No. 4

**Various Potholes in
Cul-De-Sac**

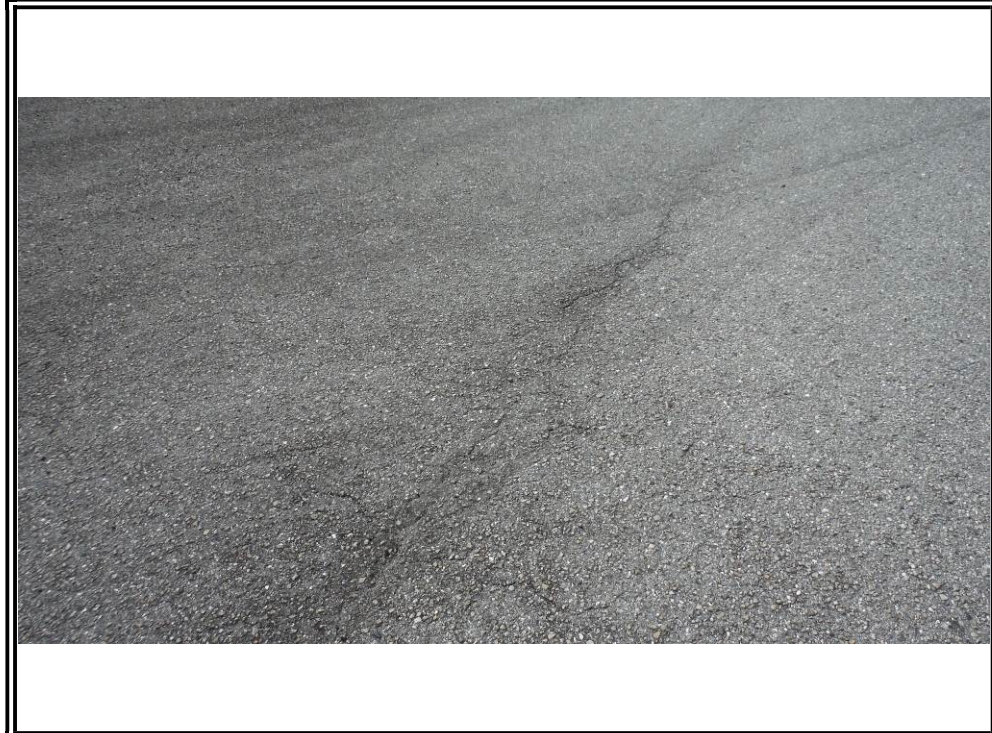
Photo No. 5
Various Minor Cracking

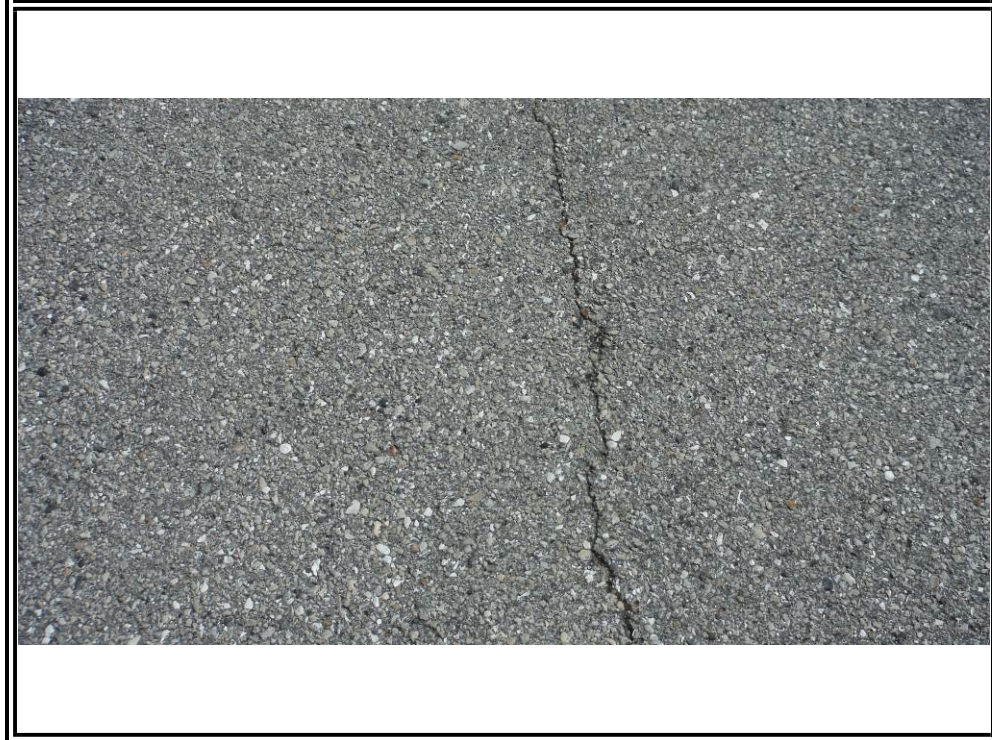
Photo No. 6
**Longitudinal Cracking
with Seperation**

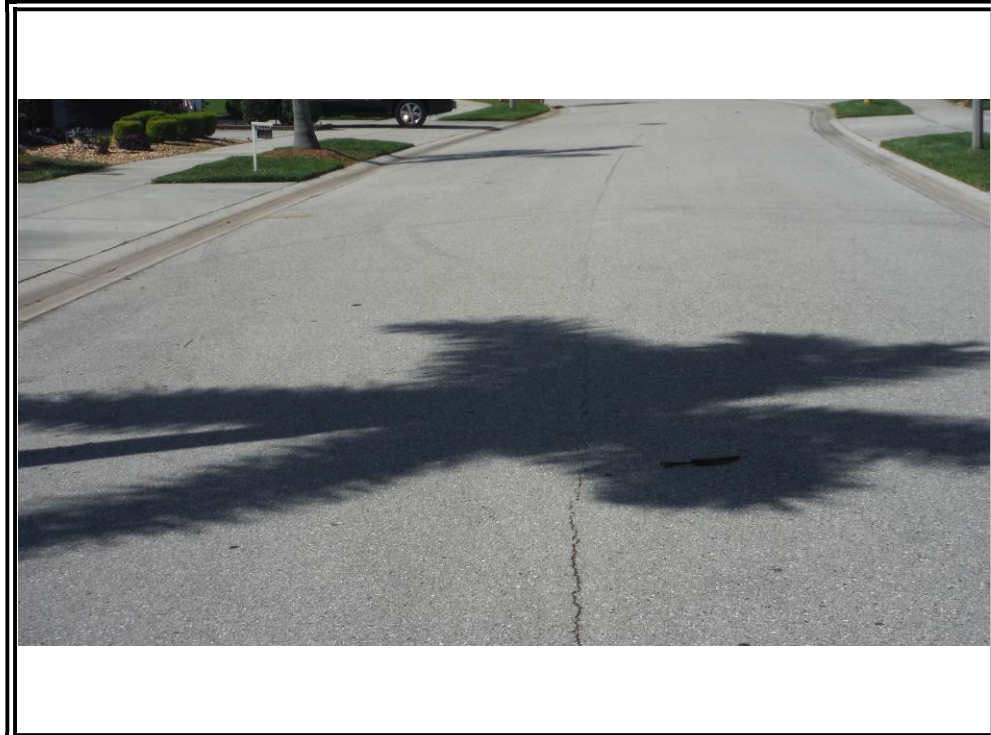
Photo No. 7
**Typical Longitudinal
Cracking**

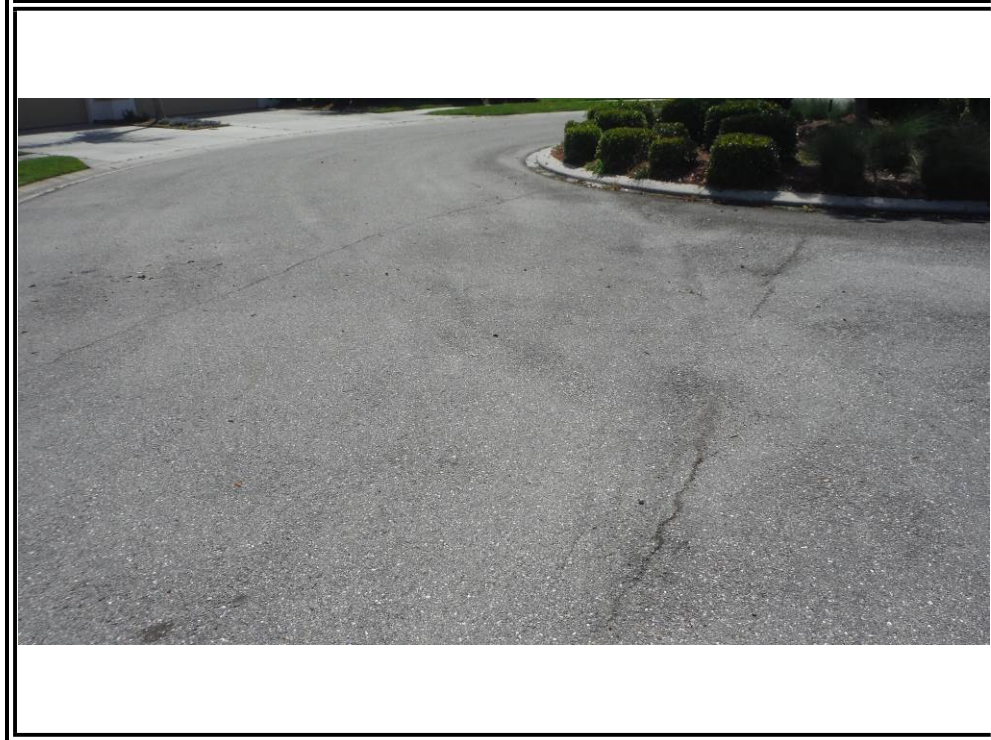
Photo No. 8
**Radial Cracking in
Cul-De-Sac**

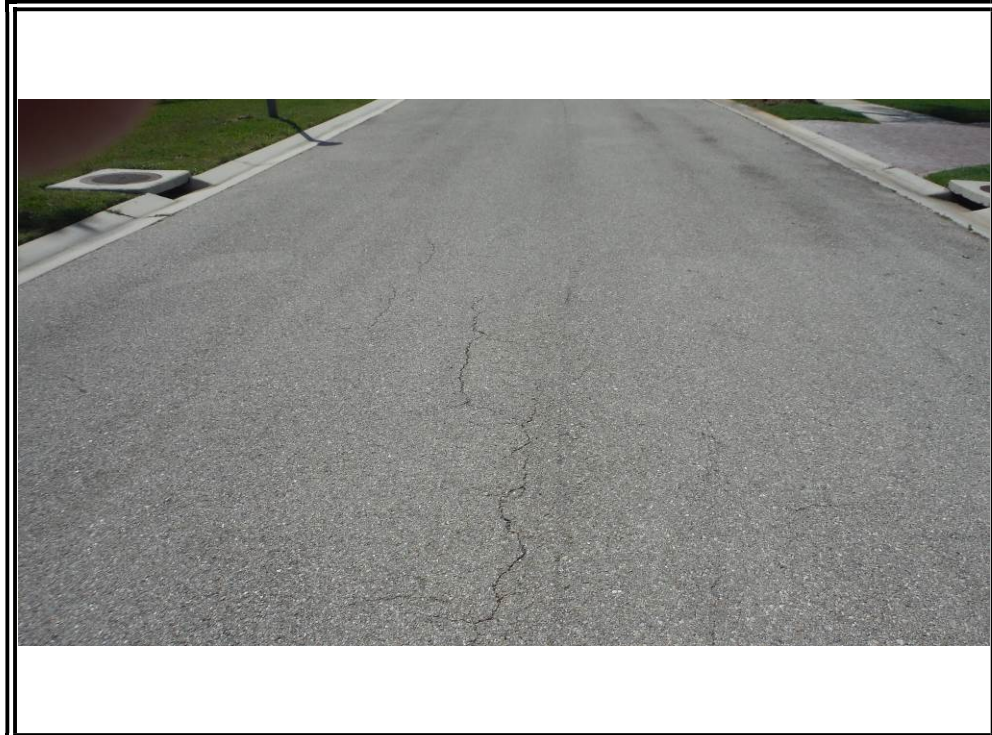
Photo No. 9

**Various Longitudinal
Cracks**

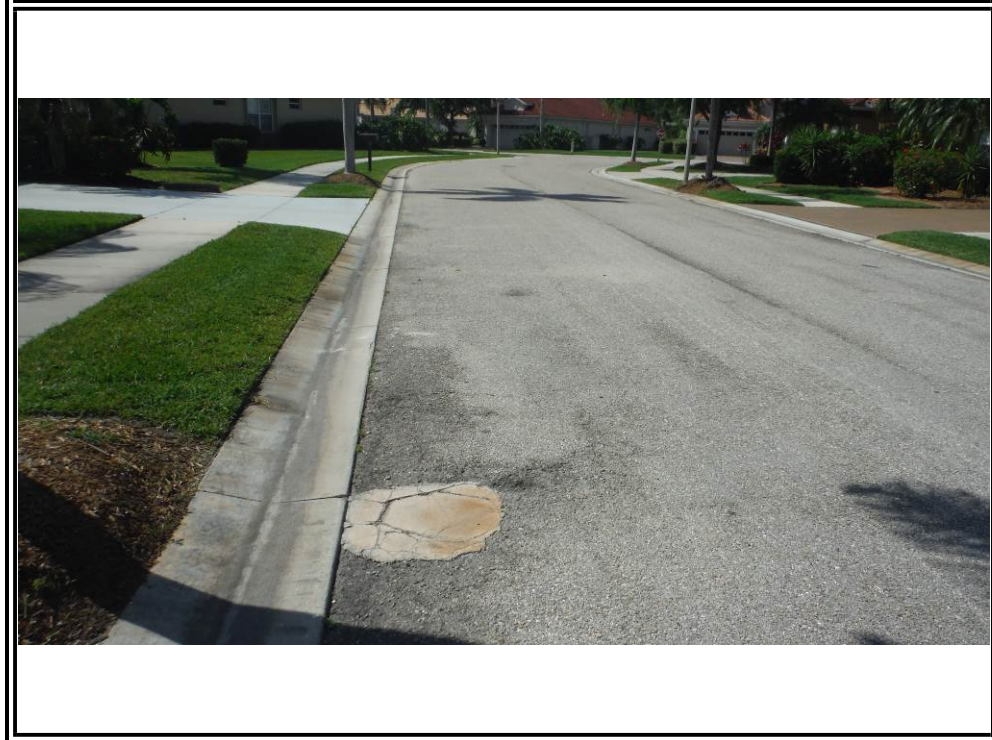
Photo No. 10

Filled Pothole

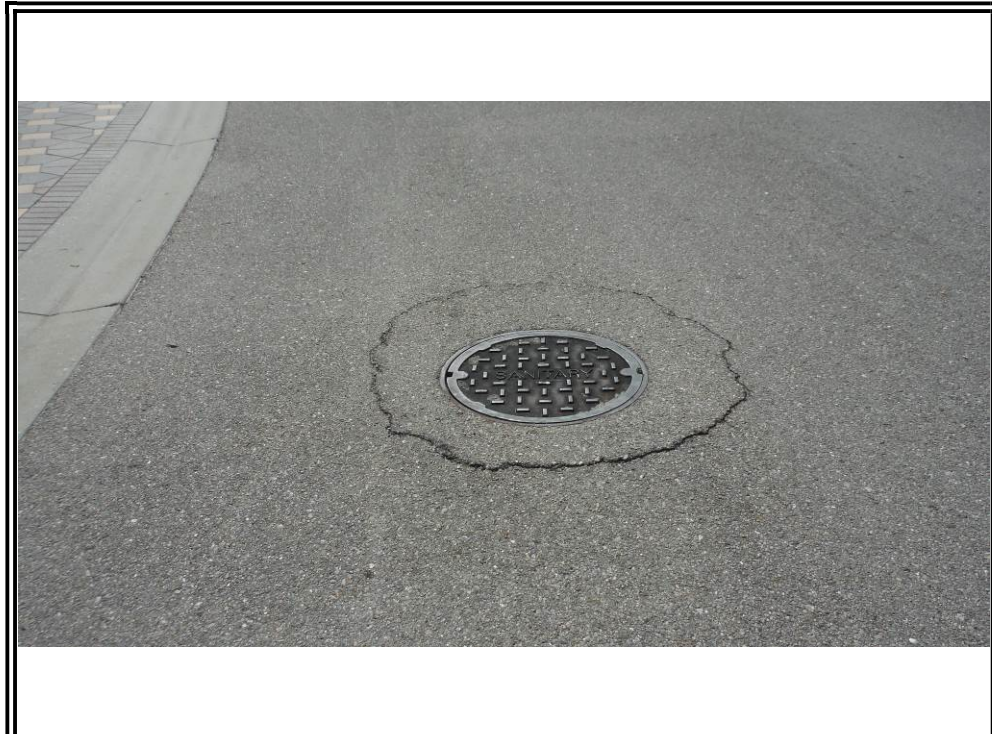
Photo No. 11
**Sewer Manhole
Settlement**

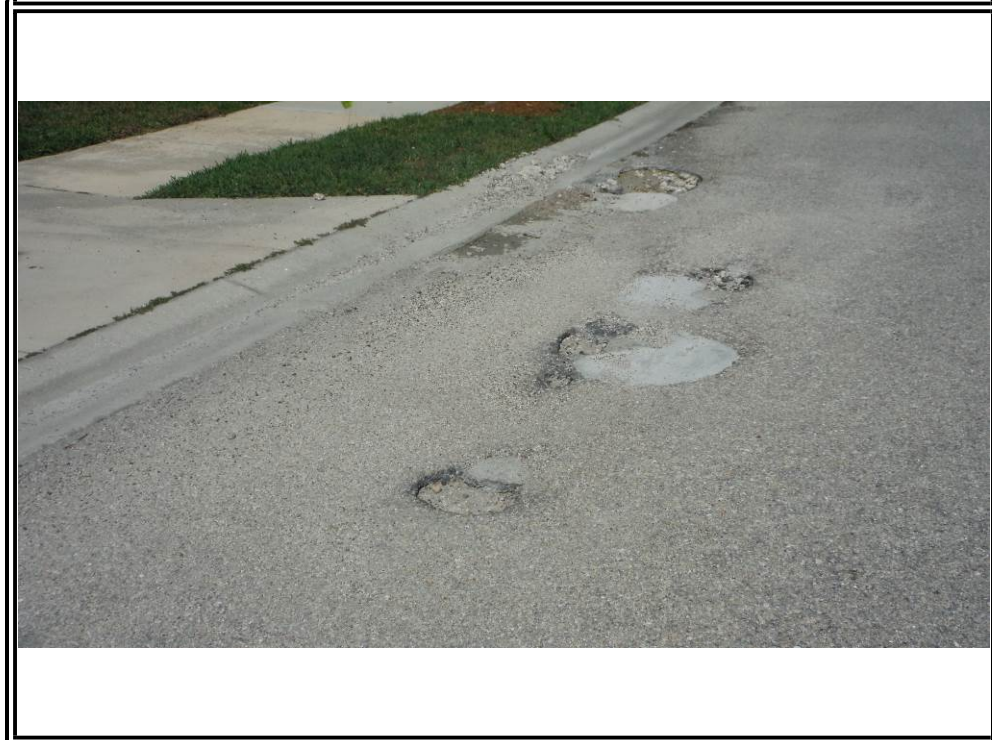
Photo No. 12
Isolated Potholes
